Manhole Inspection Summary

Manhole # S25GG_027MH

Insp Date: **9/5/07 10:35 AM**

Location Address: **905 ROBERT ST**

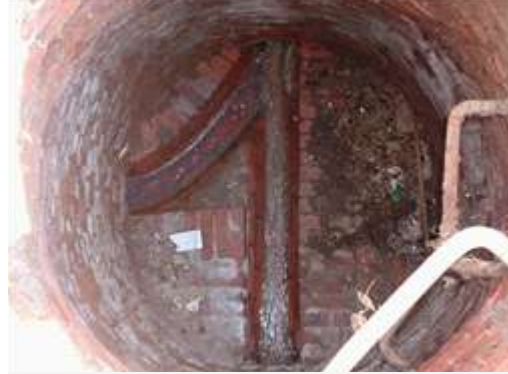
Top View

Corroded steps. Evidence of surcharge - Bench debris.

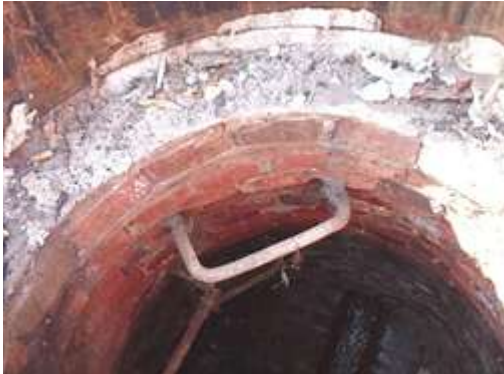
Defect

Frame leaks. Frame offset. Adjustment deterioration and infiltration. Corbel and Barrel infiltration - other side.

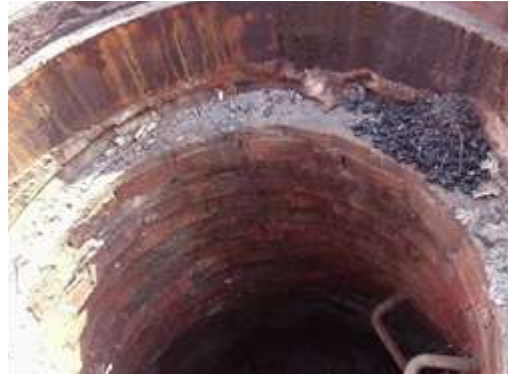
Defect

Frame leaks. Frame offset. Adjustment deterioration and infiltration. Corbel and Barrel infiltration.

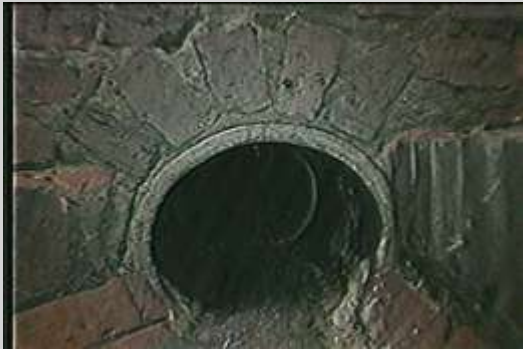
15 in. Circular Gravity Sewer Pipe Out @ 12 O'Clock

Deposits: ☐ None ☐ Mud ☐ Sludge ☐ Debris ☒ Grease

Silt Depth: **0** (in.) Deposits Extent: **Light**

Infiltration: **None** Pipe Seal Cond: **Cracked**

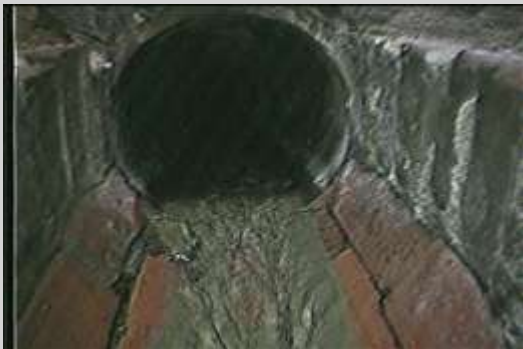
8 in. Circular Gravity Sewer Pipe In @ 6 O'Clock

Channel deterioration.

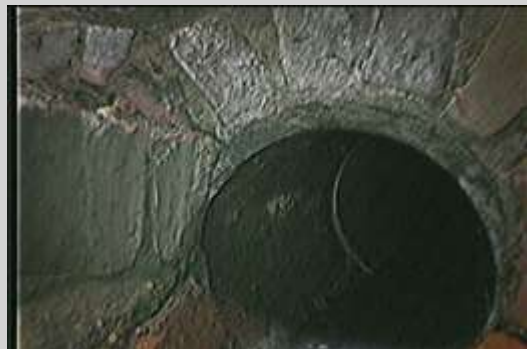
15 in. Circular Gravity Sewer

Infiltration: **Evidence**
